Manhole Inspection Summary

Manhole # S55A__028MH

Insp Date: **6/24/08 2:14 PM**

Location Address: **3500 pulaski hw**

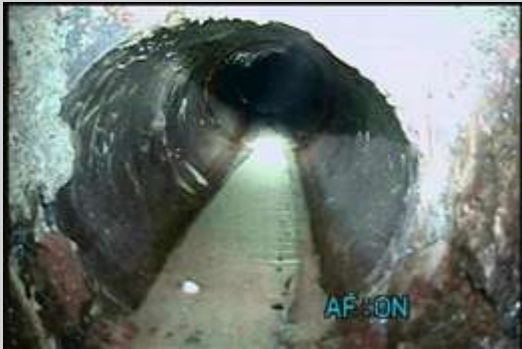
12 O'Clock Outflow

8 in. Circular Gravity Sewer
Pipe Out @ 12 O'Clock

Infiltration: **None** Pipe Seal Cond: **Unknown**
